# CC\_Pictures

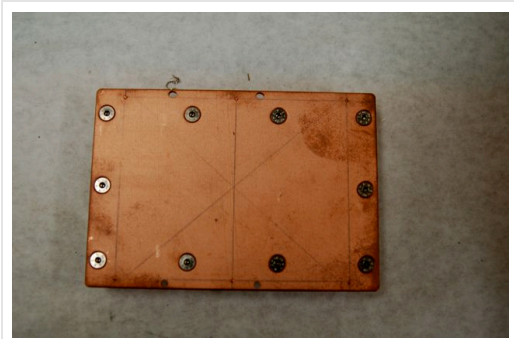
Scribe marks on hard drive cooler for placement of two thermoelectric units. This type arrangement found to be ineffectual because the large surface area leaks heat back to the aluminum plate.

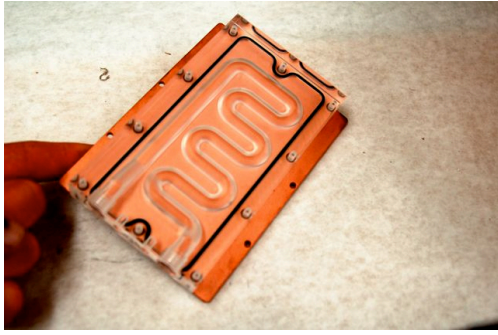
Opposite side of the hard drive cooler.

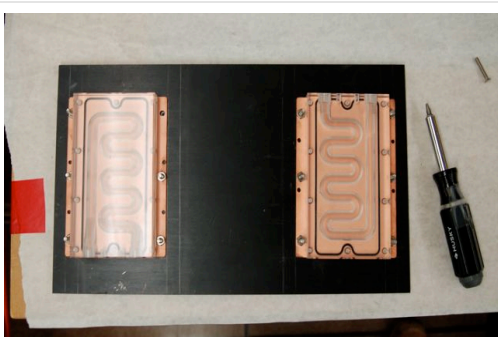
Imagine two thermoelectric units under each side.

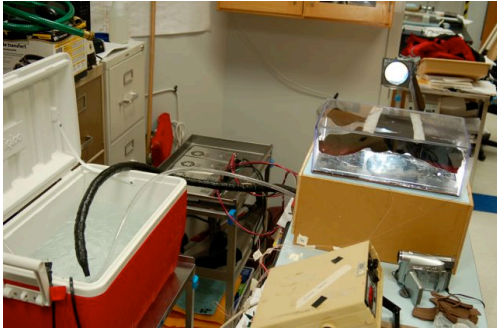
Setup prepared for operation. Note the ice bath to the left, cloud chamber to the right, and overhead light source behind the chamber.

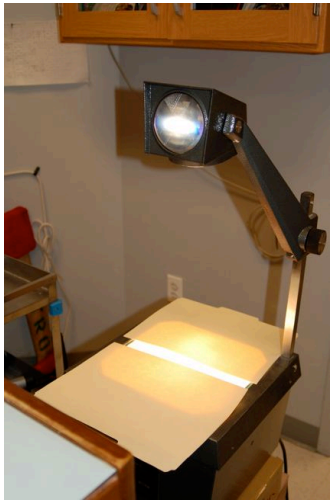
Overhead light source.

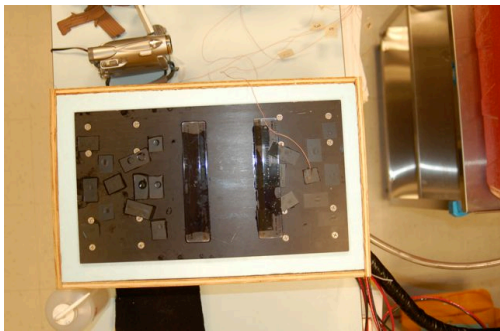
Top view of the chamber. Two 6-inch plastic rulers provide fiducial marks.

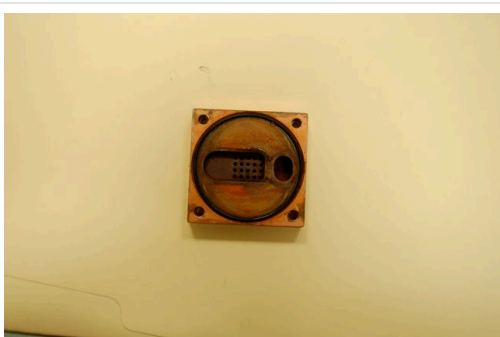
Inside of the copper water jacket. This one was removed and taken apart because of a freeze failure.

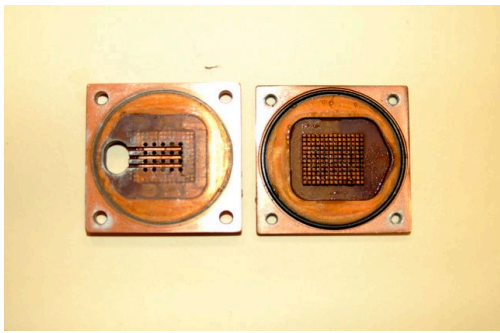
Inside the heat exchanger. Note the lint build-up on the right side.

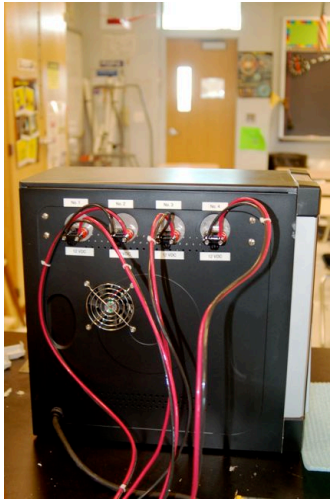
Modified computer case with power supplies inside.

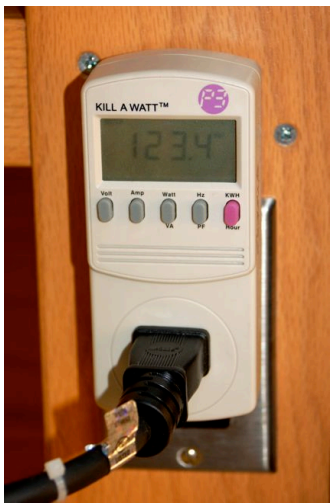
"Kill-A-Watt" meter with plugged in power supply.

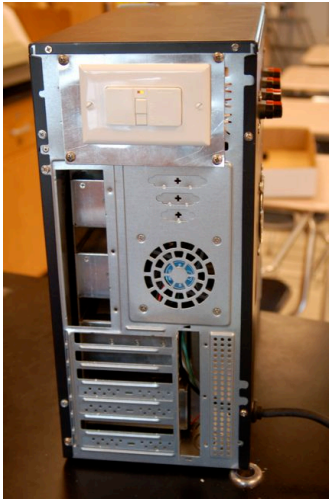
GFCI switch turns on the four internal power supplies.

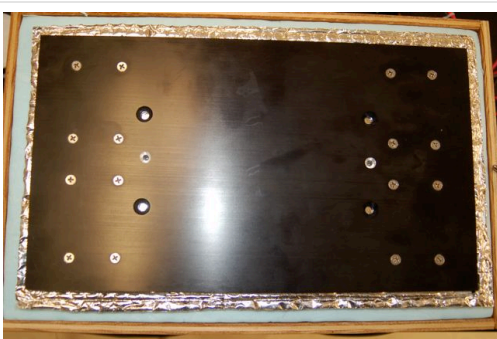
The aluminum base of the chamber without the lexan cover.

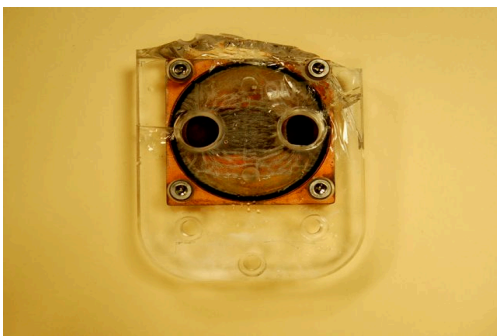
Working at near freezing temperature can be hazardous. The plastic was replaced with machined aluminum blocks for all four heat exchangers.

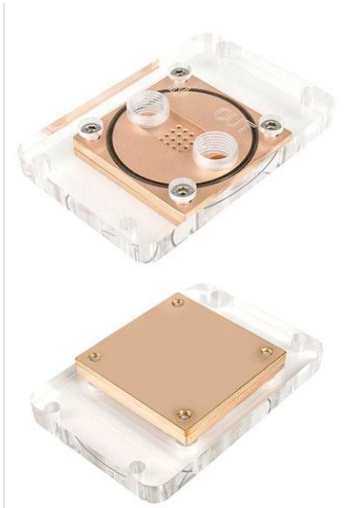
Heat exchanger as it appears new from the box.
